DMPS FACILITY ASSESSMENT |

EXECUTIVE BUILDING SUMMARY

Building Name: Stowe Elementary

Date: 10.25.2023

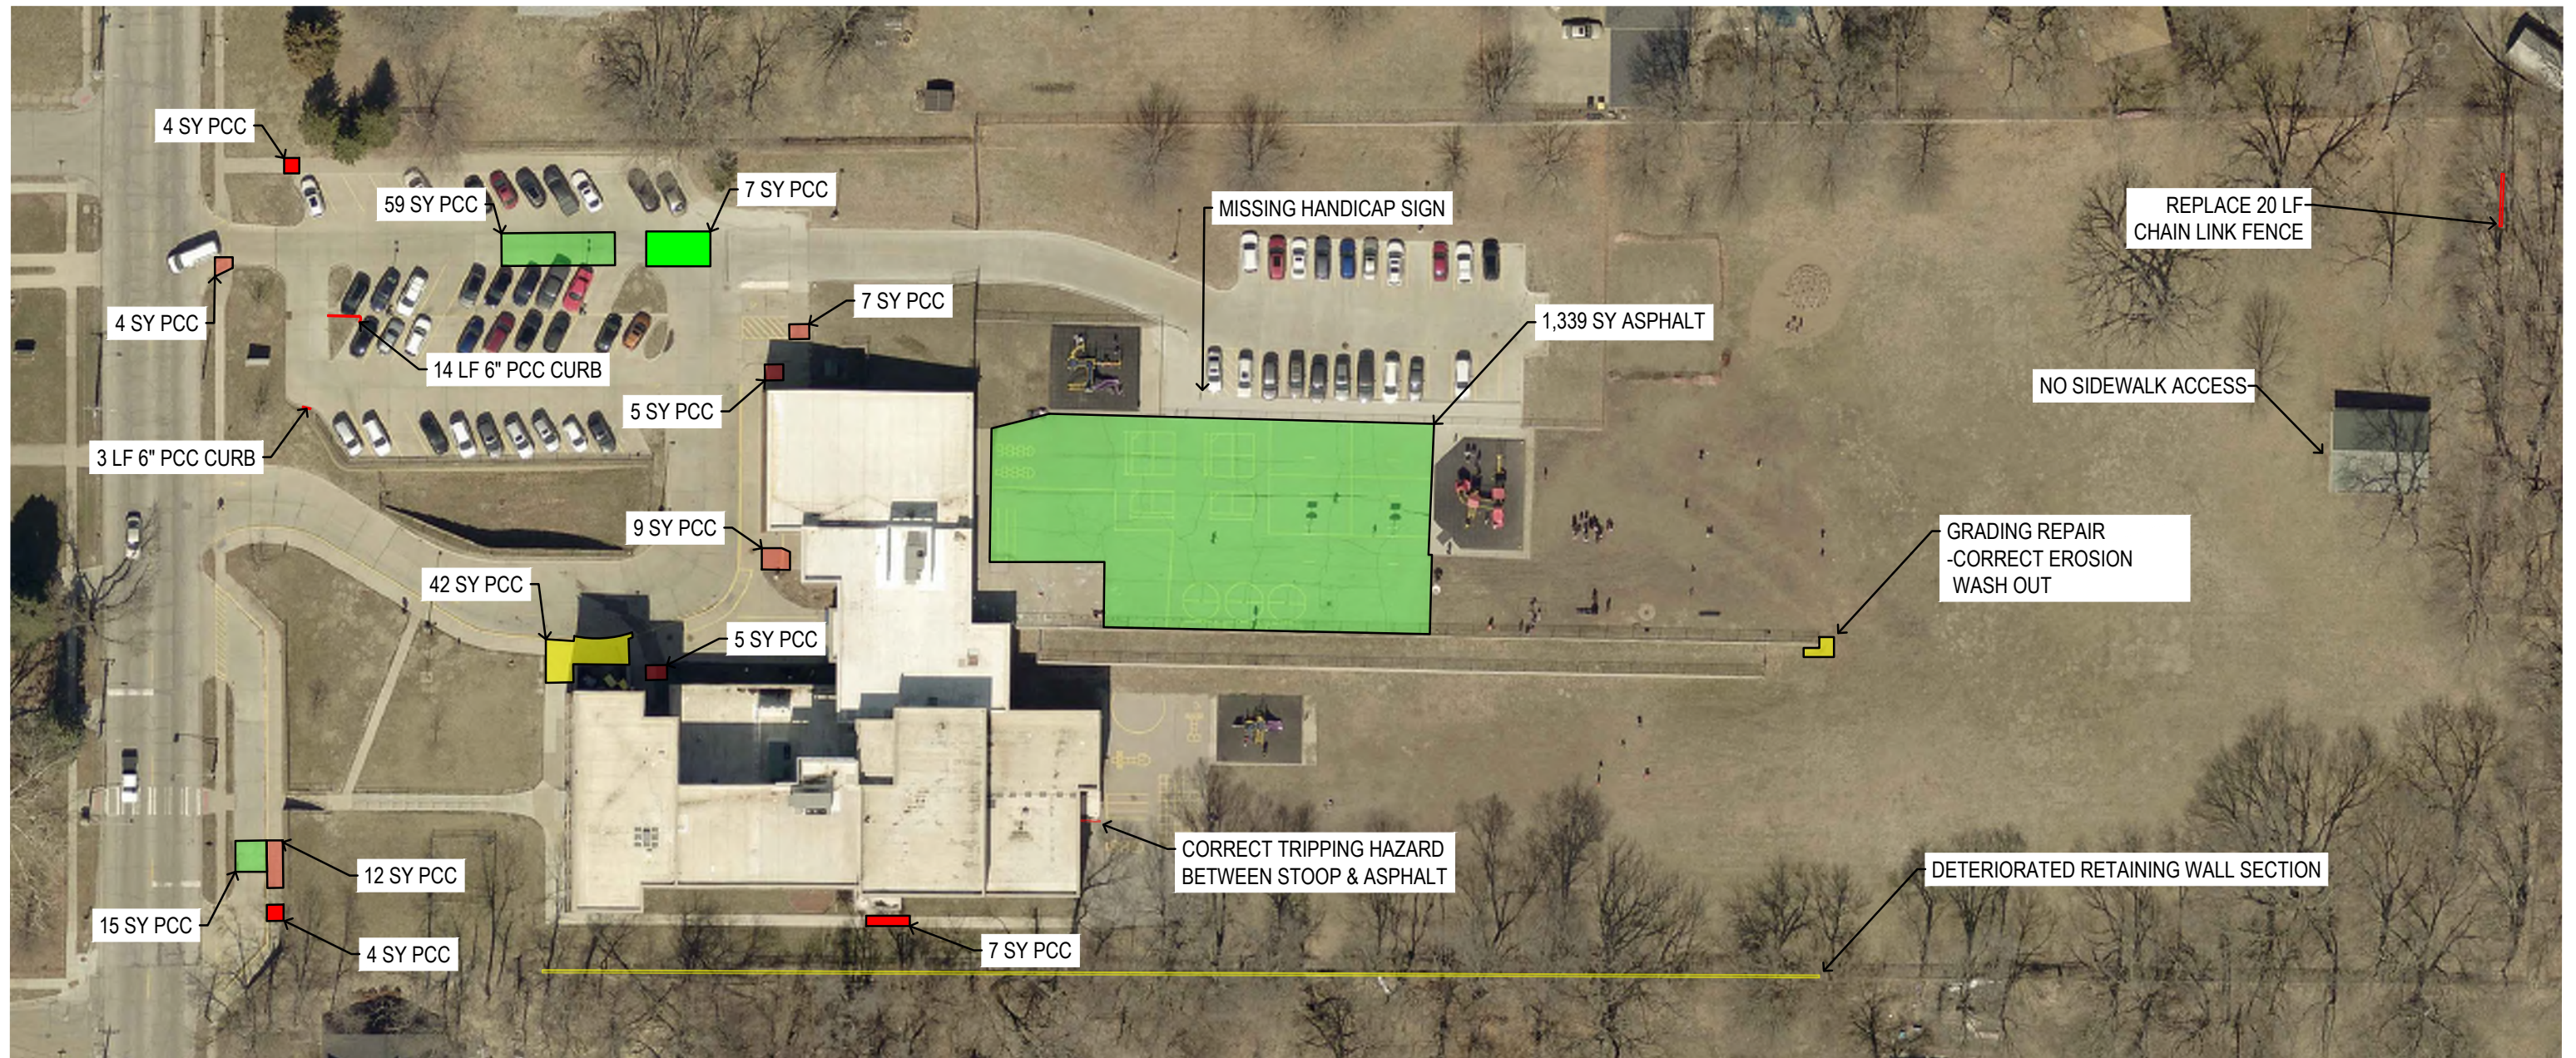
- 5+ YEAR REPLACEMENT
- 3-4 YEAR REPLACEMENT
- 1-2 YEAR REPLACEMENT

Pavement Repairs	Replace pavement panels and fix tripping hazards by entryways. For locations, refer to civil site plan exhibit found in the appendix of this report.
Stoop Replacement	The stoop outside of the southwest exterior exiting door should be replaced and sloped away from the building. Approximately 20SF of stoop replacement.
Hot Water Mixing Valve Replacement	Replace mixing valves with electronic mixing valve and connect to DDC for monitoring.
Ventilation and Exhaust System Improvements	Modify newly installed ventilation system to demand based ventilation provide additional CFMs of outdoor air to classrooms. Current system is only 50 to 60% of recommended CFMs.
Heat Pump Replacement, Classrooms	Replace remaining heat-pumps that are over 15 years in age. Corridors, conference and commons. Consider a two-speed style heat-pump to reduce demand on wellfield.
Boiler Installation	Add gas fired supplemental hot water boiler 500MBH for supplemental heat and existing elec boiler (500 MBH) for backup and peak heating.

Drainage Repair	Repair the wash out by the middle retaining walls. For location, refer to civil site plan exhibit found in the appendix of this report.
Pavement Replacement	Install reinforced PCC in front of trash enclosure. For location, refer to civil site plan exhibit found in the appendix of this report.
Retaining Wall Replacement	Retaining wall to the south of the site should be replaced. Civil and structural concerns with existing conditions. Approximately 500 LF for replacement. See civil exhibit for location.
Mixing Valve Installation	Install digital mixing valve in place of existing and include DDC for monitoring. Re-balance hot water recirc and include auto flow valves.

Restore playground asphalt pavement. For location, refer to civil site plan exhibit found in the appendix of this report.

Remove and replace degenerated sections of parking pavement. For location, refer to civil site plan exhibit found in the appendix of this report.
